Debris/Ice/TPS Assessment and Integrated Photographic Analysis of Shuttle Mission STS-67

Gregory N. Katnik, Barry C. Bowen, J. Bradley Davis

Technical Memorandum 110651

April 1995

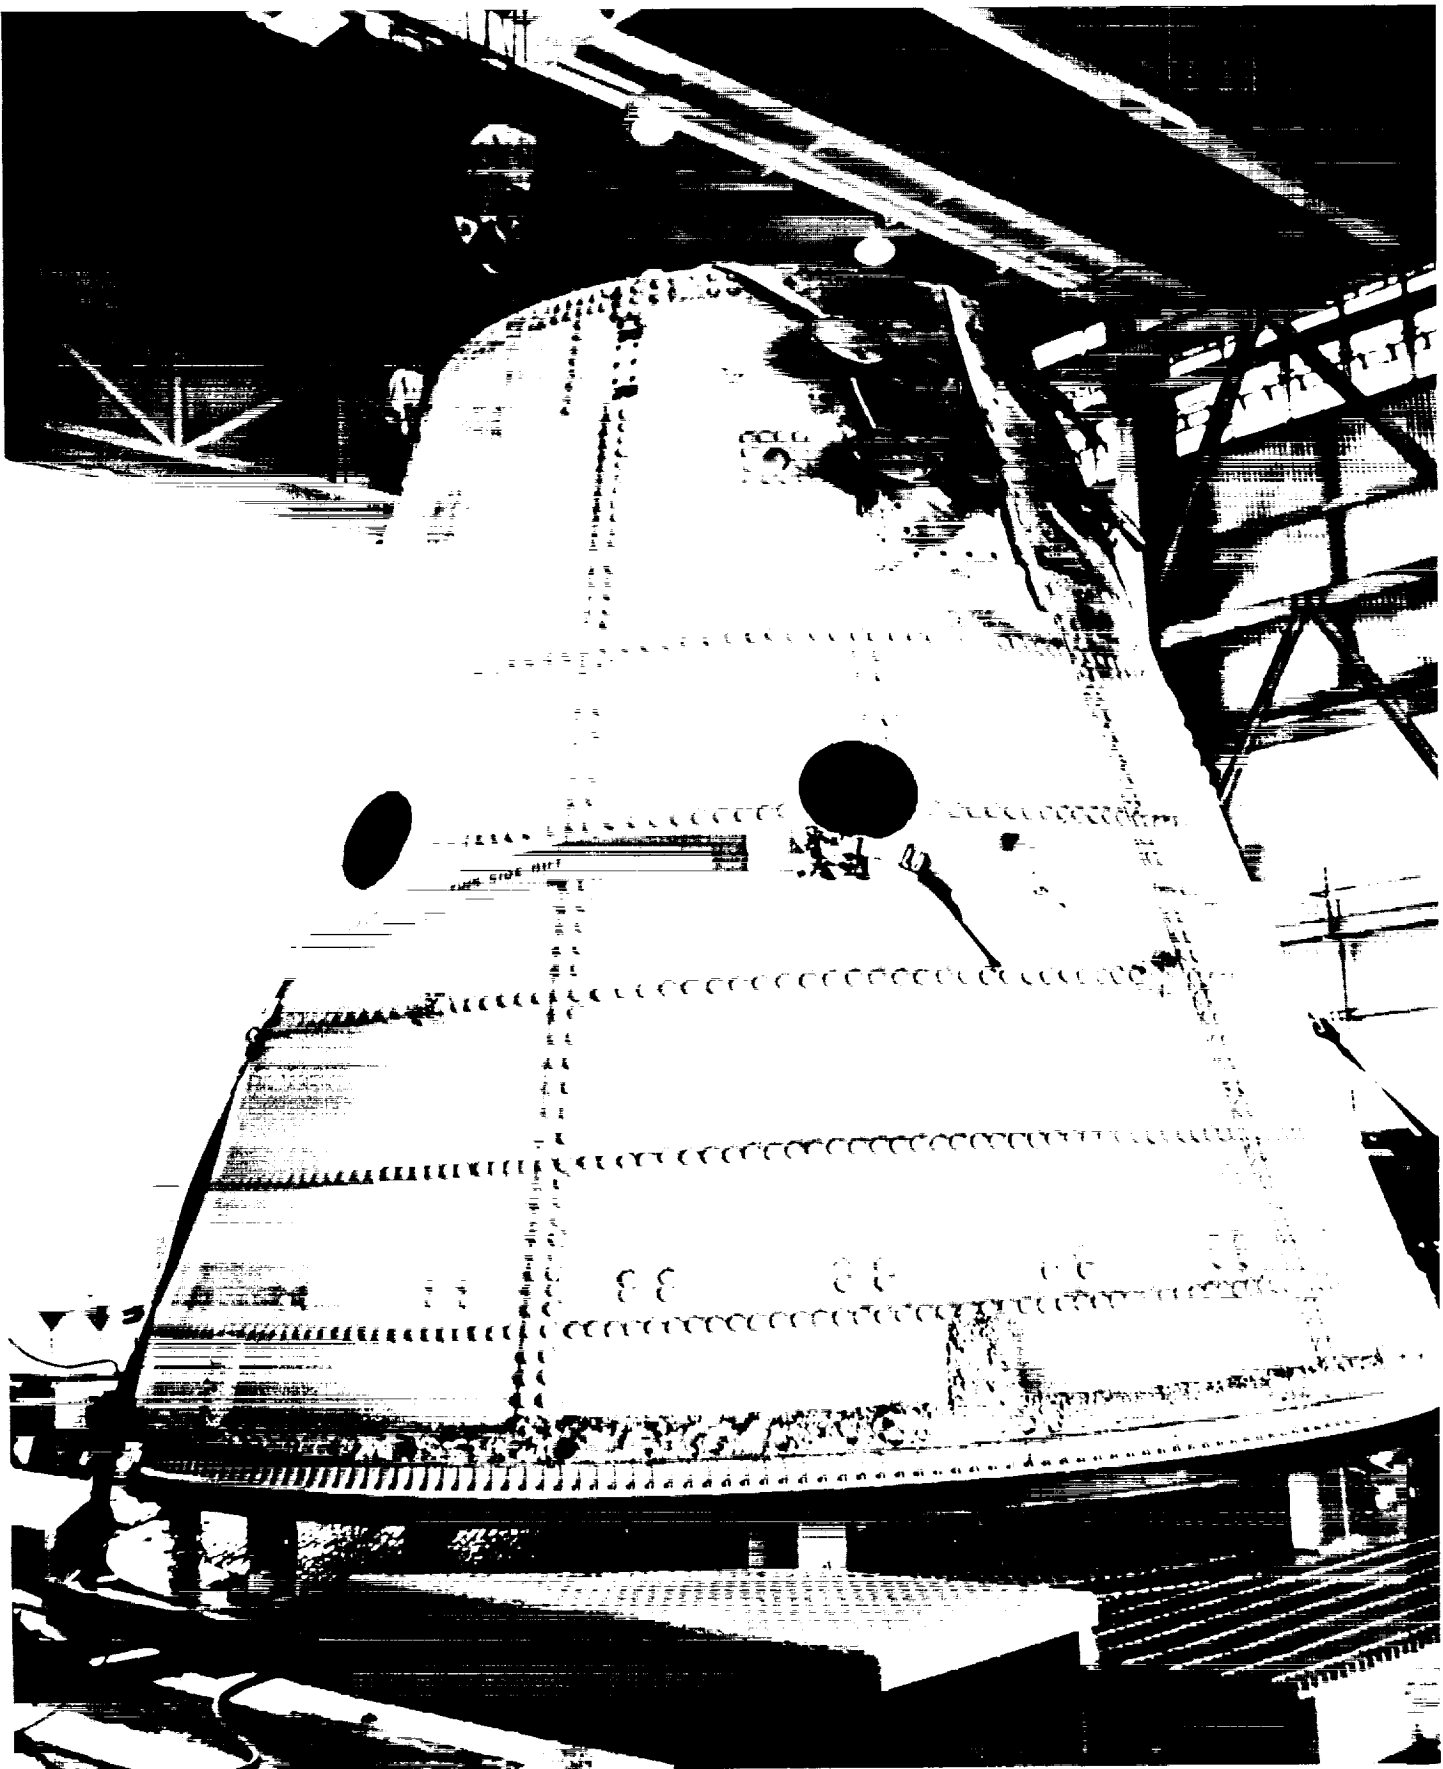
Photo 12 : RH Frustum

The number of debonds over fasteners was average. Hypalon paint was blistered/missing along the XB-395 ring frame where BTA had been applied. Some of the underlying BTA was sooted.

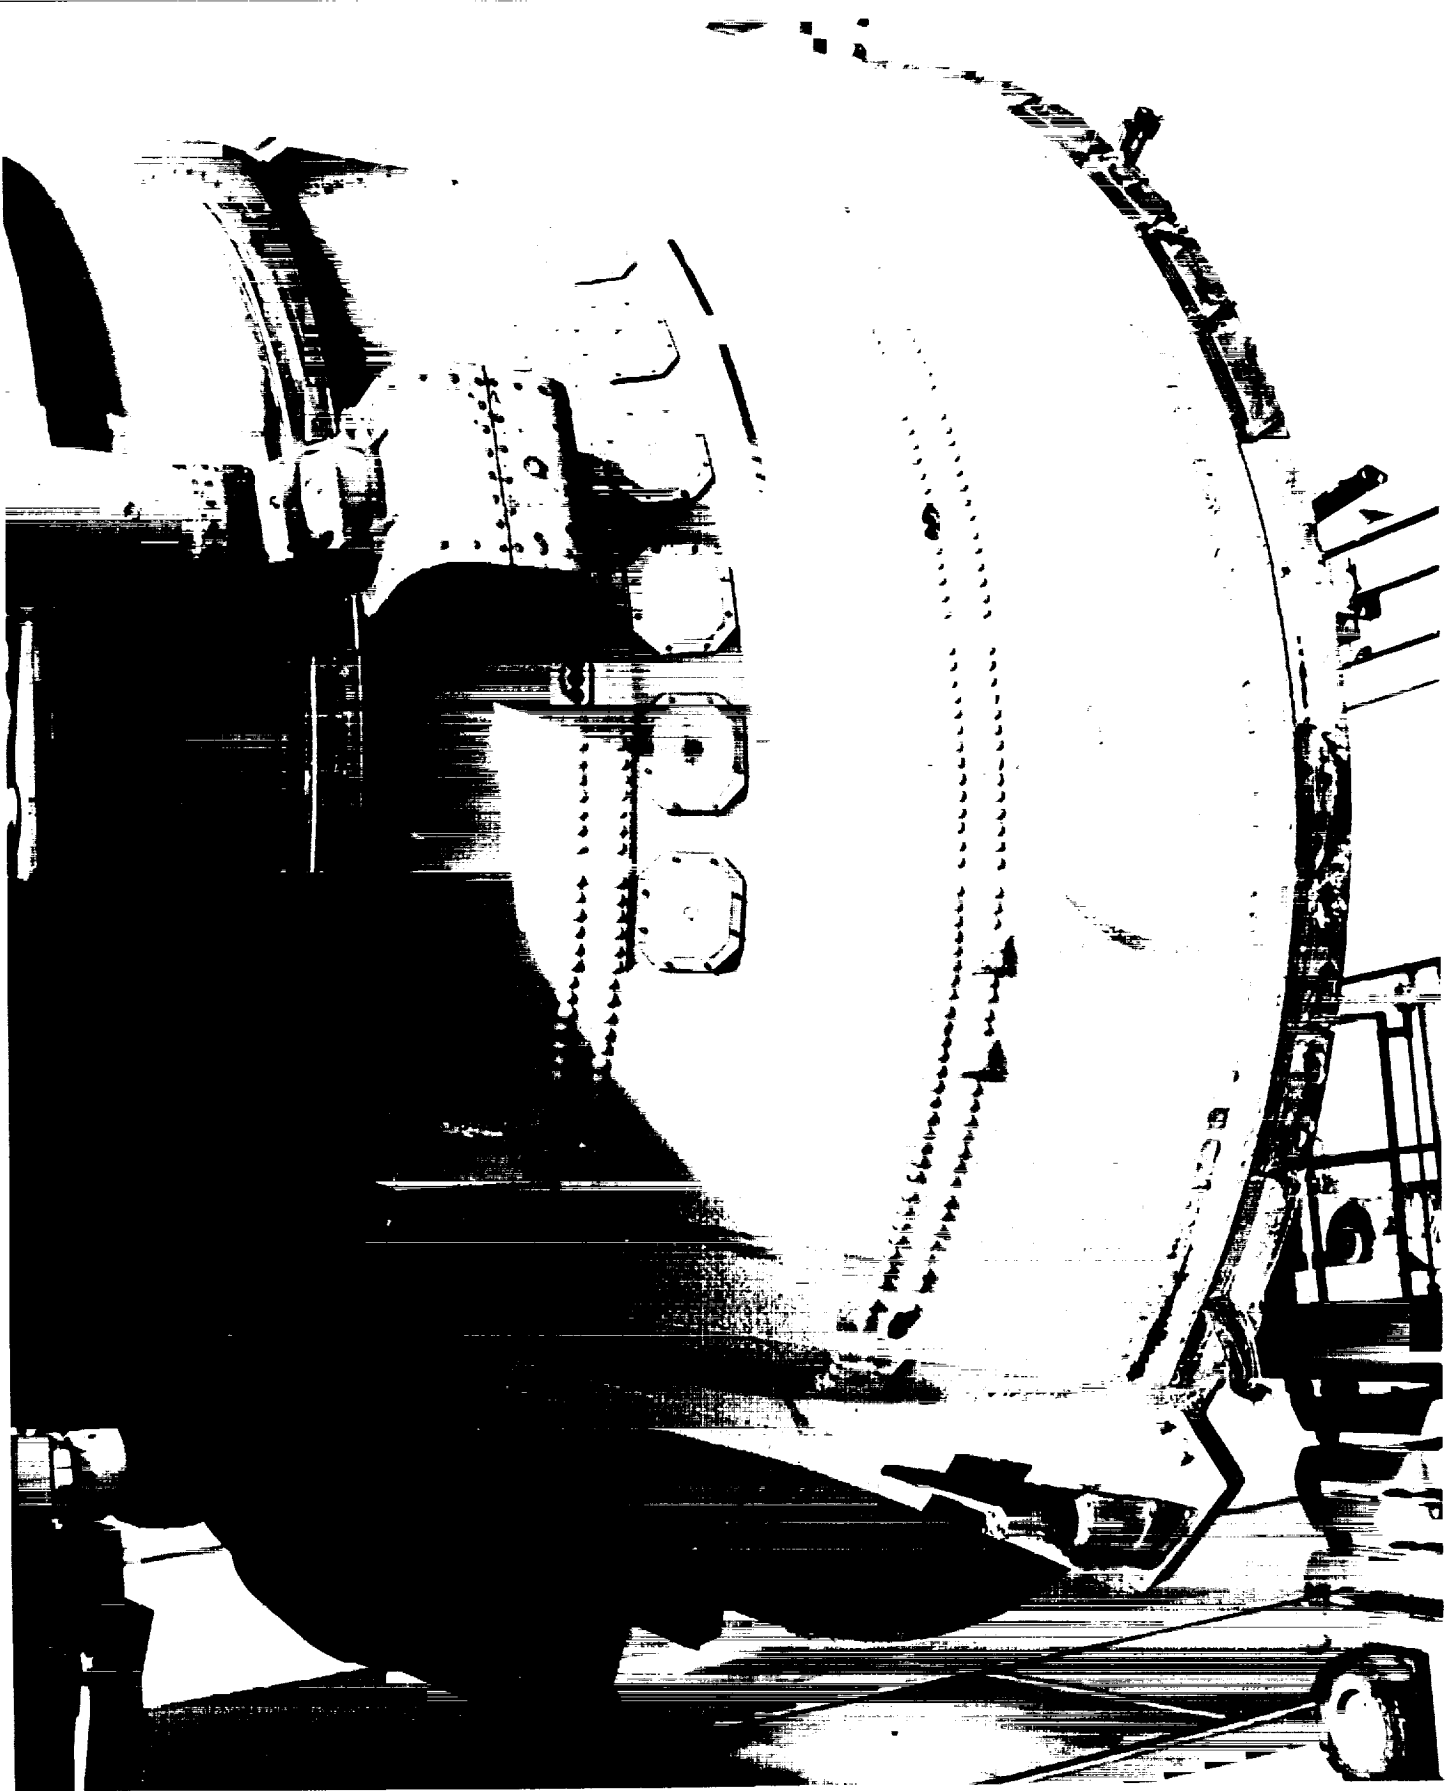
Photo 15 : RH SRB Aft Skirt

MSA-2 was missing from aft skirt acreage in seven places. Most of the MSA-2 divots, which averaged 3-inches by 3-inches in size, appeared to expose lightly-sooted substrate. Hypalon paint was blistered/missing over the areas where BTA closeouts had been applied.

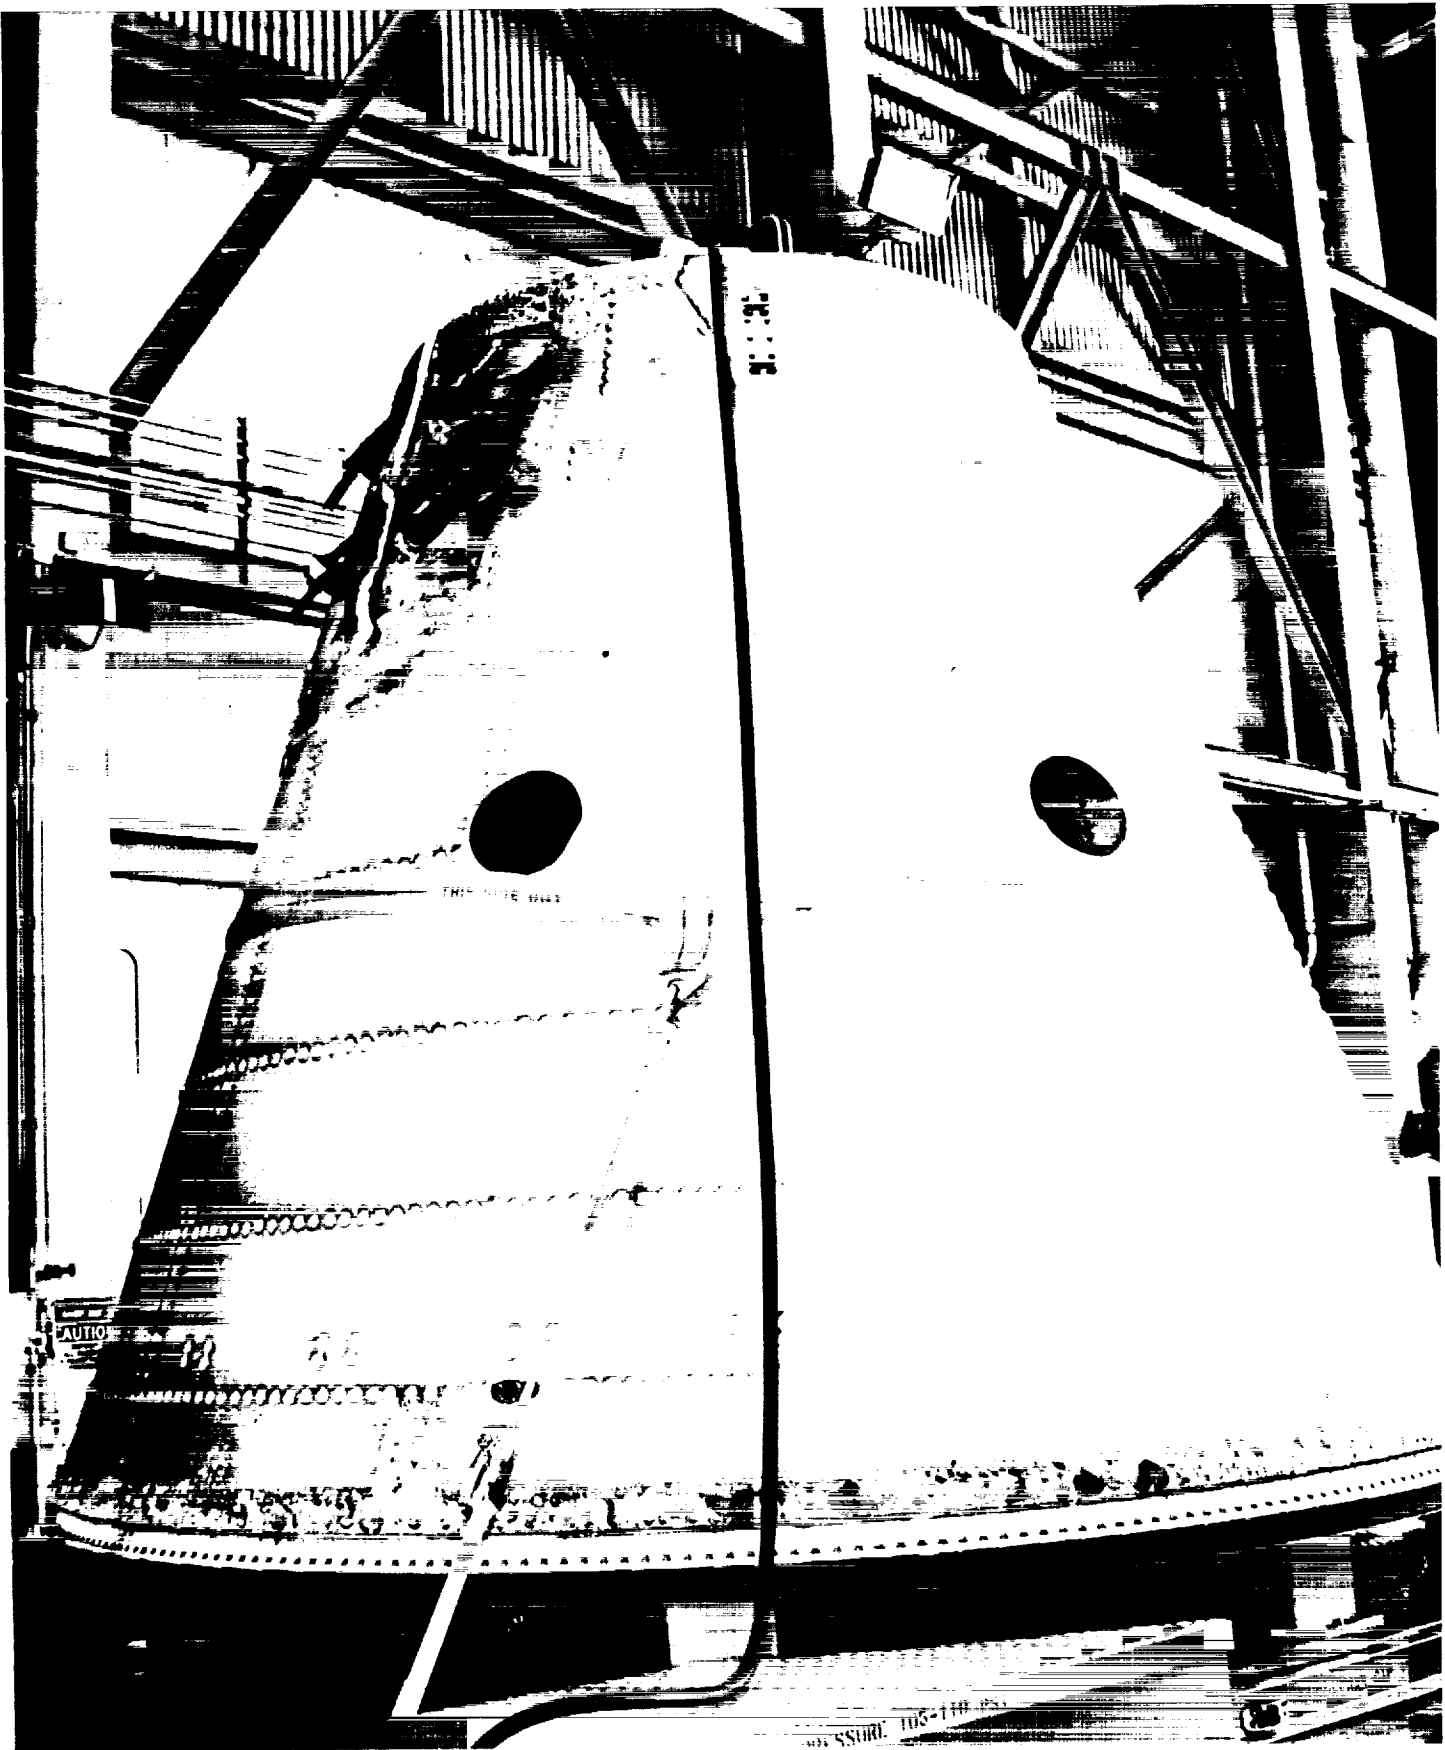
Photo 16 : LH Frustum

The number of MSA-2 debonds over fasteners was average. Hypalon paint was blistered/missing along the XB-395 ring frame where BTA closeouts had been applied. Some of the underlying BTA was sooted.

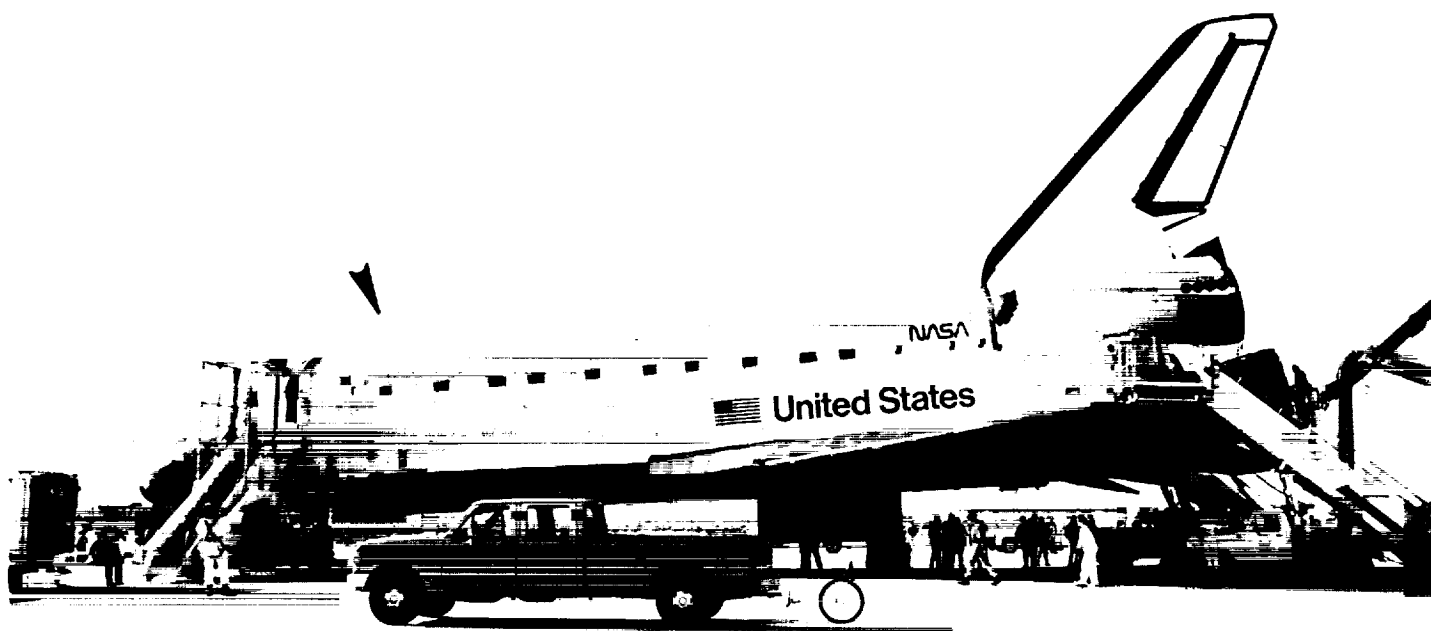
Photo 20 : Overall View of Orbiter Left Side

Note discoloration on leading edge of left payload bay door

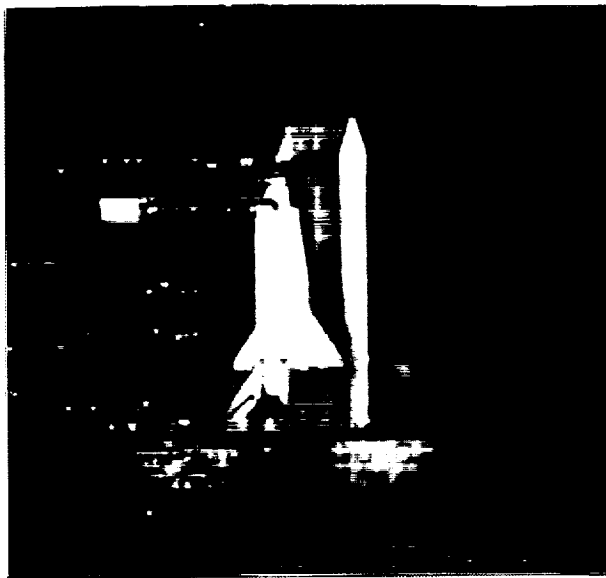
Figure 2.2.1: White Vapor near the RH SRB Aft Skirt at T-21 Seconds

White vapor was noted rising from the MLP area just to the east of the Shuttle Launch Vehicle at approximately T-21 seconds. The vapor was first seen near the RSRB aft skirt. KSC reported the white vapor to be smoke from the RH SRB hydraulic power unit. No follow-up action was requested.

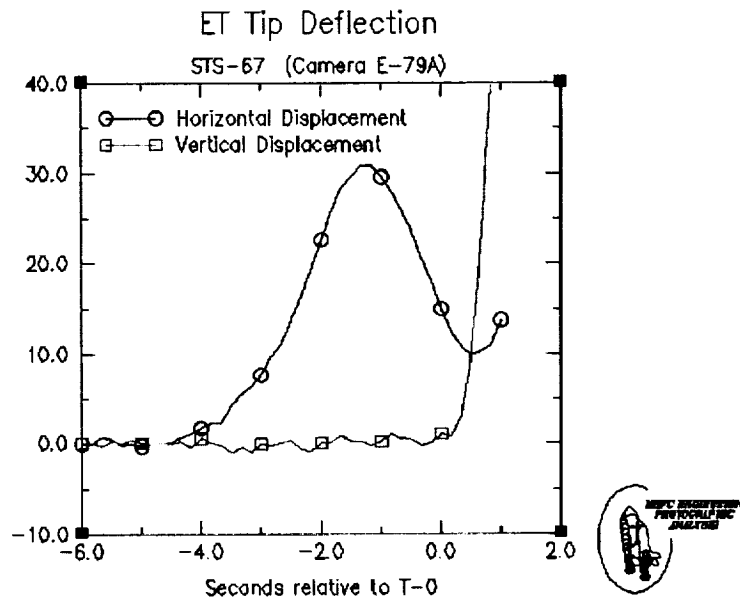
Figure 10 ET Tip Deflection

Maximum ET tip deflection for this mission was measured to be approximately 31 inches. Figure ten is a data plot showing the measured motion of the ET tip in both the horizontal and vertical directions. A positive horizontal displacement represents motion in the -Z direction. These data were derived from film camera E-79A.
